**ANNUAL REPORT
FOR THE
ROCKY FLATS ENVIRONMENTAL TECHNOLOGY SITE
GROUNDWATER PLUME TREATMENT SYSTEMS
January 2003 through December 2004**

August 1, 2005

SW-A-005120

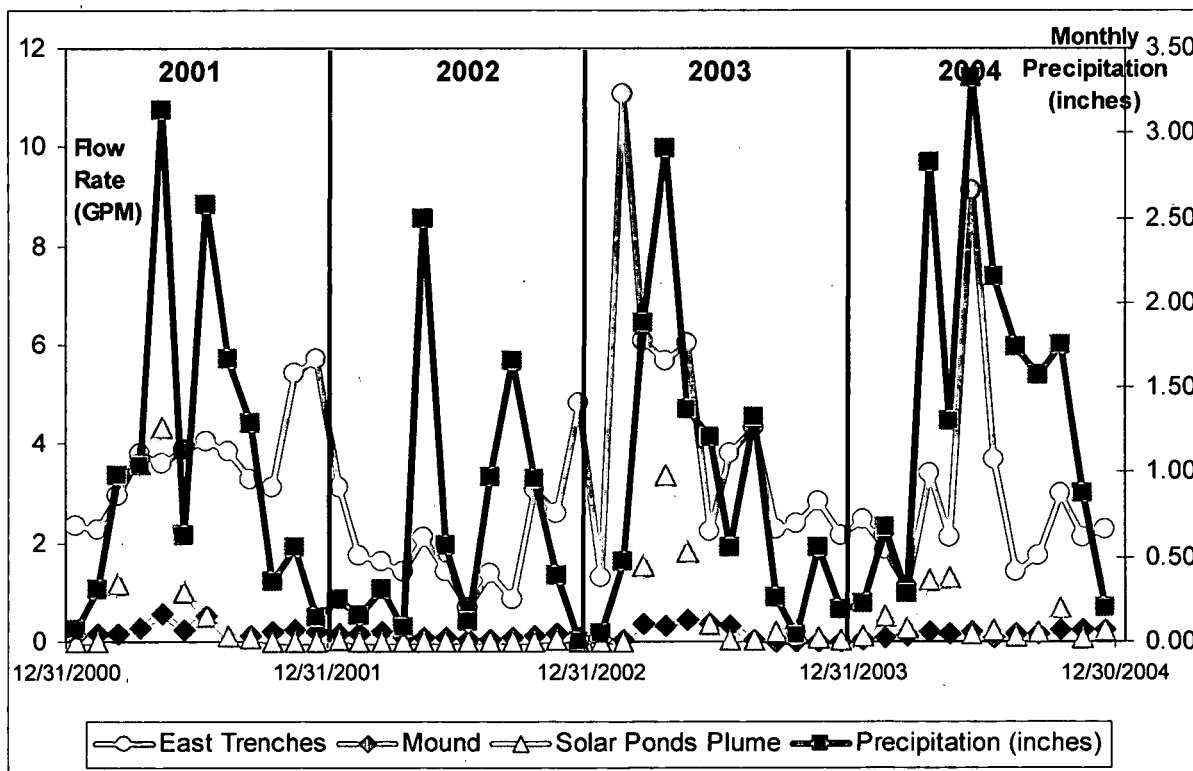
Figure 2. Monthly Precipitation vs. Average Monthly Flow Rates for Mound Site Plume, East Trenches Plume and SPP Treatment Systems

Based on the estimates of groundwater flow in the East Trenches Plume PAM (DOE 1999b), the projected recovery from the trench was 5.3 gallons per minute. As shown on Figure 2, the captured flow often exceeds this flow rate. Even during 2003 when there were still impacts from the drought, the average flow rate for the year was 4.23 gallons per minute. Based on this, the collection system is operating as designed, and bypass is limited in extent.

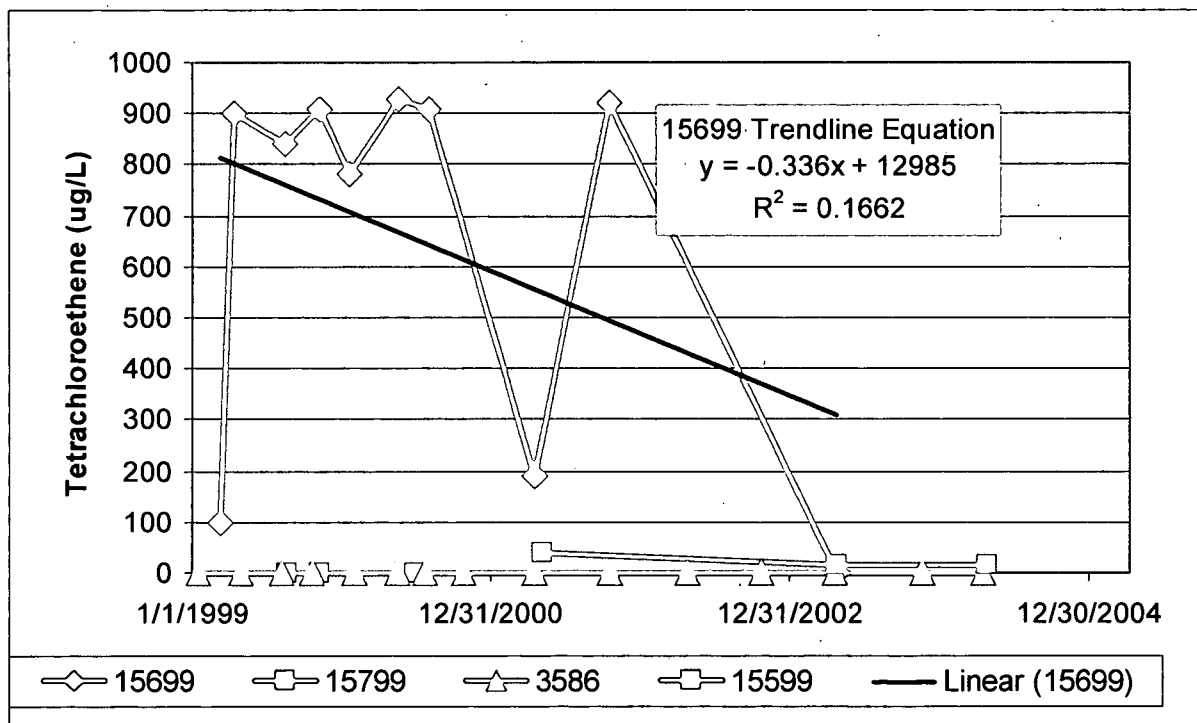
Figure 4. Mound Site Plume Downgradient PCE Concentrations

Cis-1,2-dichloroethene and vinyl chloride are degradation products of the primary groundwater contaminants in this plume. The low concentrations seen in the downgradient wells are probably a result of the residual, pre-existing plume and generally not a byproduct of the treatment

process. The treatment system is effective in removing uranium, and any uranium in the downgradient wells is a result of residual contamination or naturally occurring uranium.

Concentrations in the downgradient wells indicate that the residual contamination levels appear to be declining and that the collection system tends to mitigate downgradient plume concentrations. For example, concentrations at Well 15599, frequently dry in the past, have decreased since the previous sample collected in 2001. Although there is variability in the concentrations, a decrease in TCE concentrations was noted in Well 15699. PCE concentrations are more variable, and the downward trend is not as evident. This well is located within the preferential flow path for the Mound Site Plume and along the trend of the highest plume concentrations defined in the pre-remedial investigation (DOE 1997a).

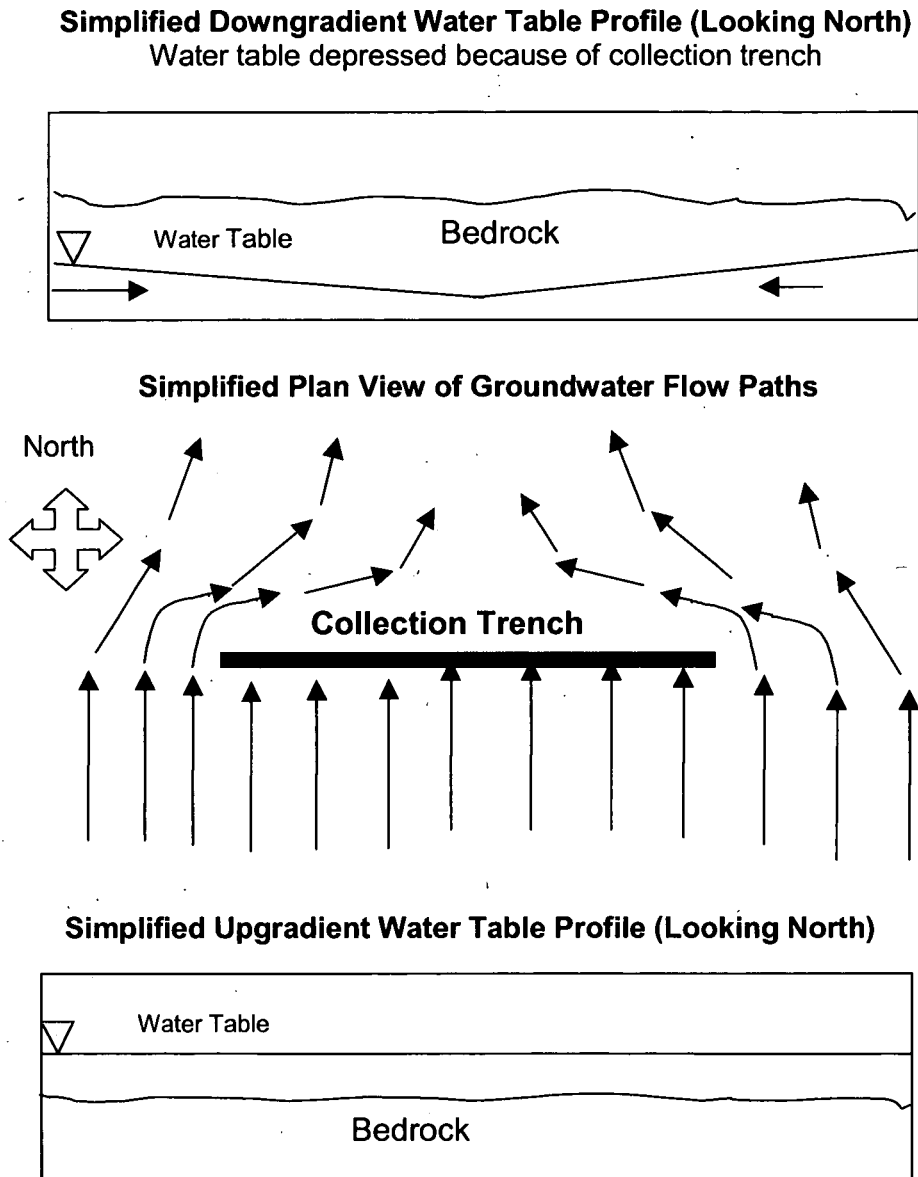
Figure 6. Conceptual Model of Groundwater Flow near the Mound Site Plume Collection Trench

Water elevations are shown on Figure 5. A simplified conceptual model of groundwater flow near the collection trench is shown on Figure 6. The hydraulic gradient induced by the trench can be seen in the difference in water elevations driving the water from the edges of the capture area, toward the center of the downgradient portion of the plume.

After the March 2003 precipitation event, a measurable water level was re-established at Well 15599 on the western side of the Mound Site Plume, but not at 15799. The increase in water levels was likely a result of the heavy snow pack melting and percolating downwards into the groundwater. The slope on the eastern side of the collection trench is flatter and may have allowed for more percolation into the soil. On the steeper sloped, western side of the collection trench, snowmelt is more likely to become run-off. By July, the downgradient groundwater profile returned to normal conditions illustrated on Figure 6. This is consistent with the intended design and indicates that the collection system is working effectively.

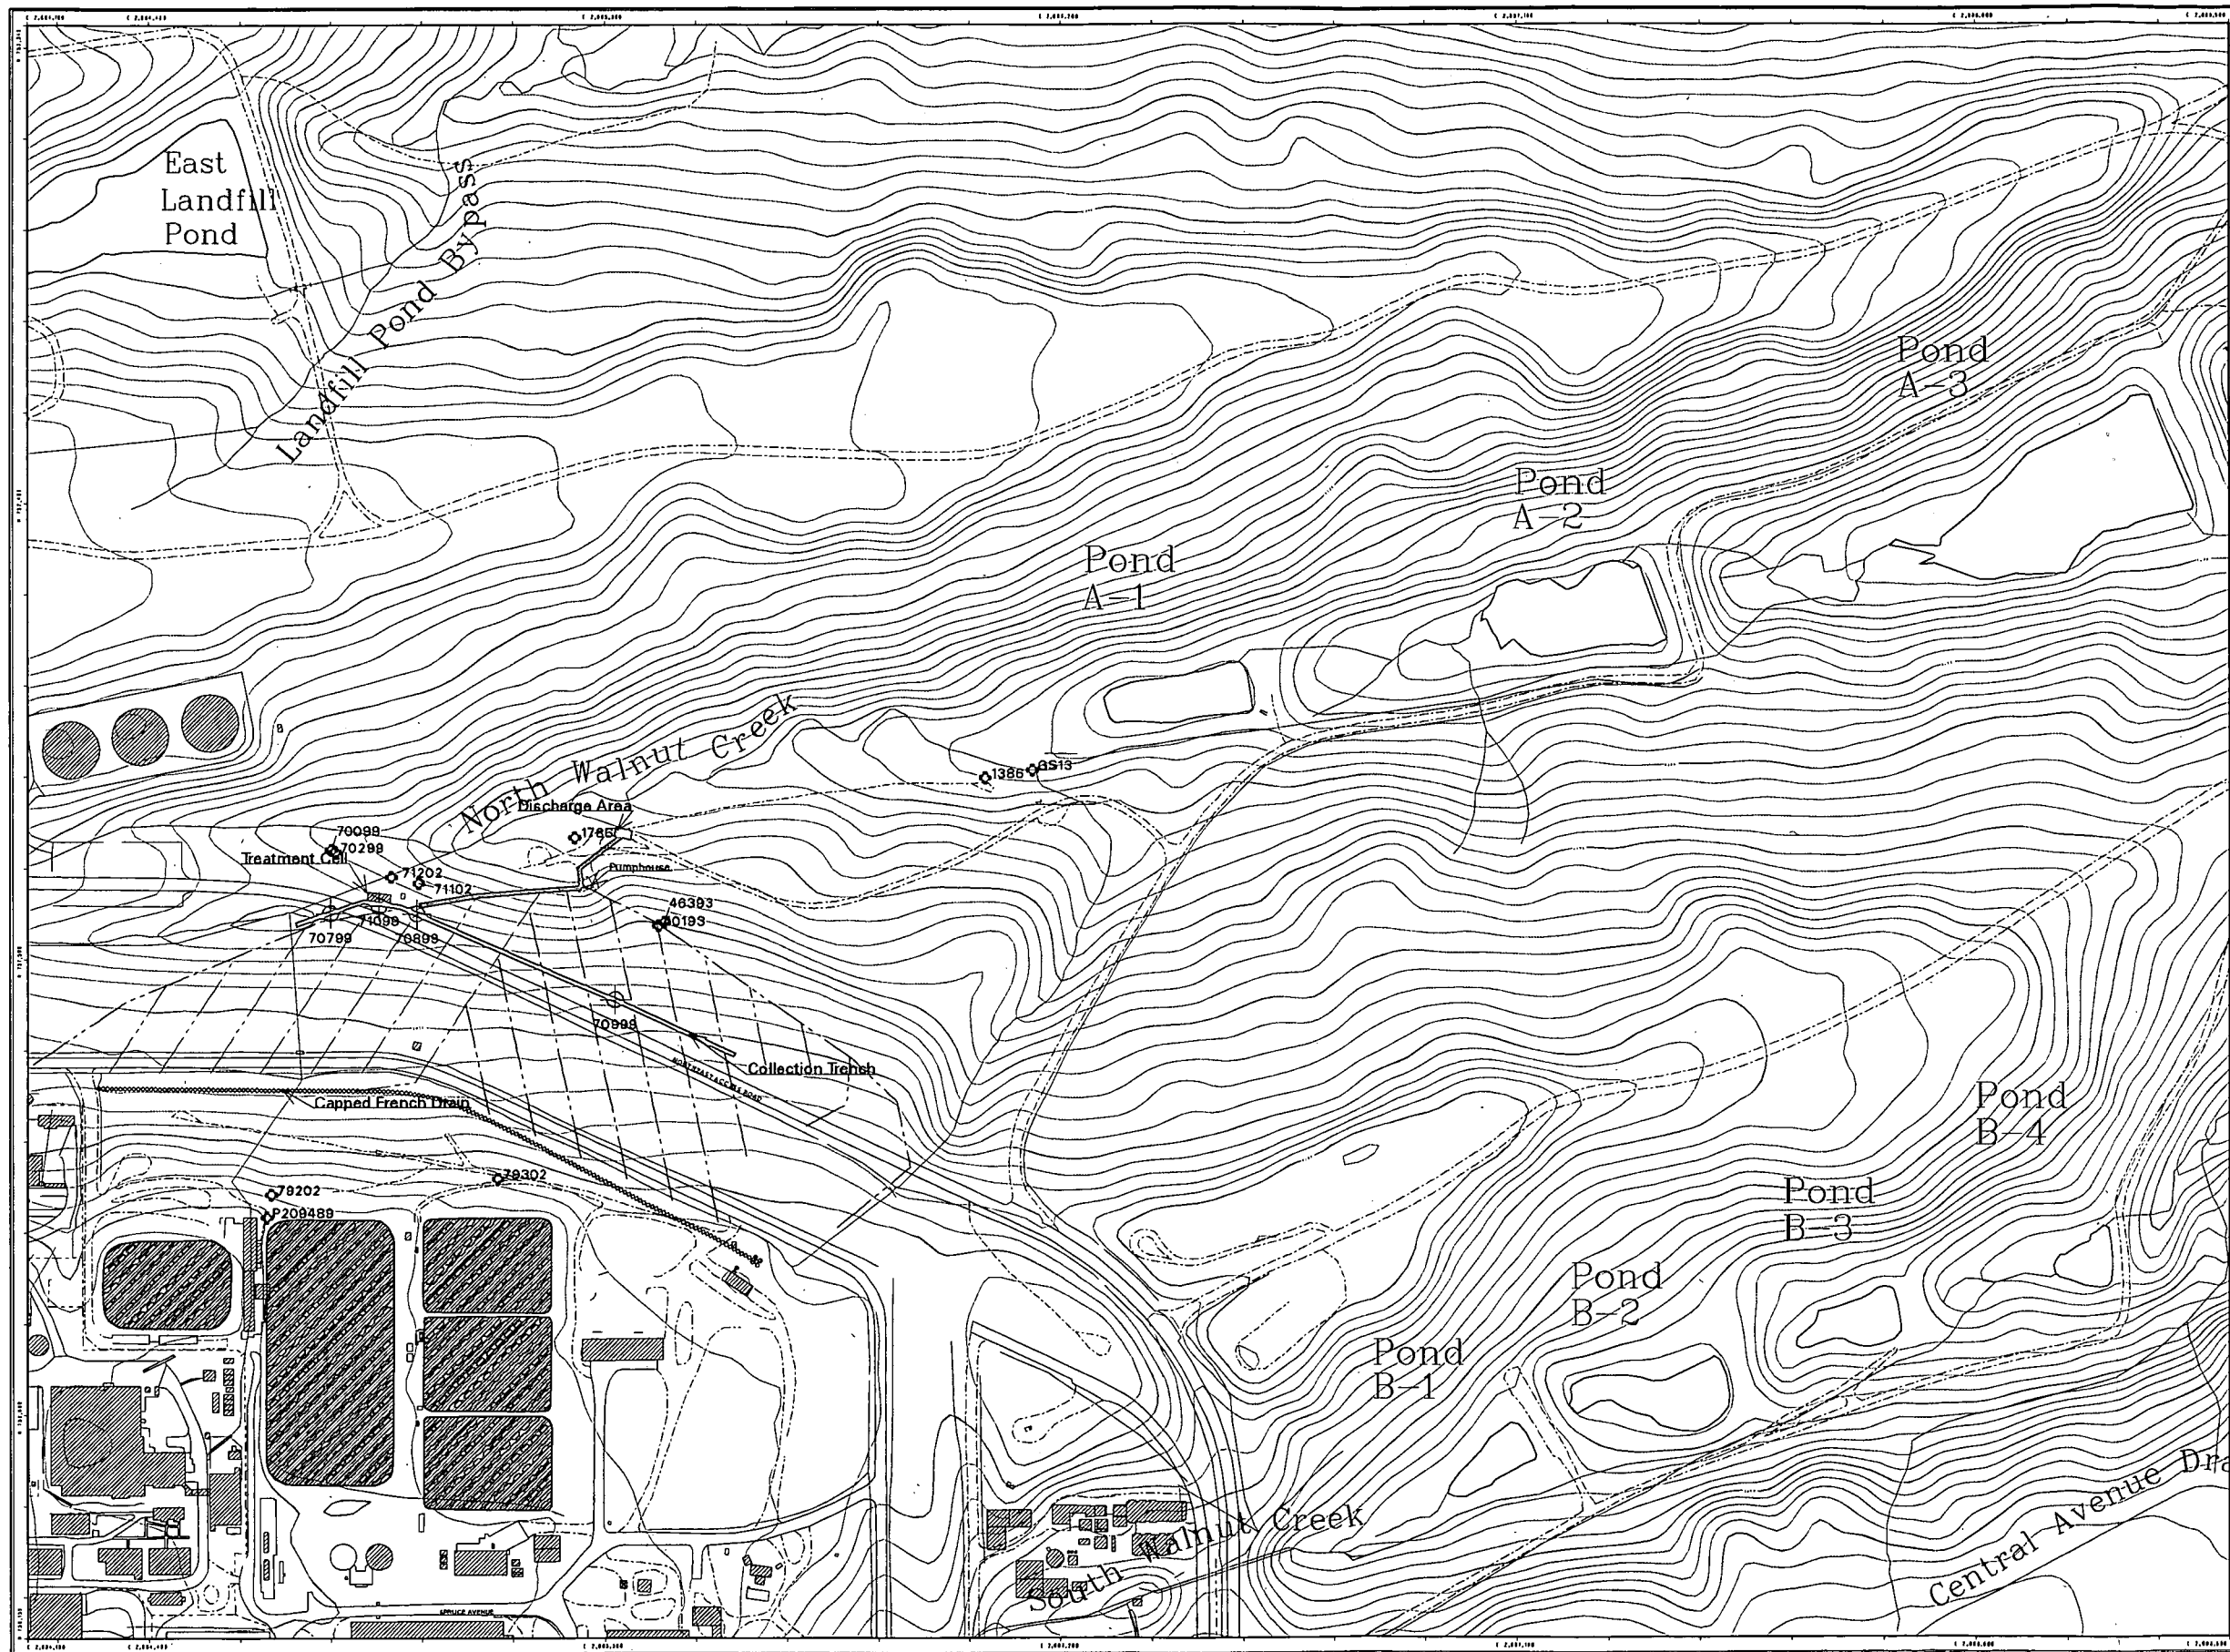
Figure 14
Solar Ponds Plume
Treatment System Locations

Wells 40193 and 46393 (Figure 14) are also upgradient of the discharge gallery. Although they are a little farther to the east, they probably have similar nitrate concentrations and uranium activities to the groundwater migrating into the discharge gallery. Well 46393 was sampled in December 1997 prior to the installation of the collection trench and had a nitrate concentration of 970 mg/L and total uranium isotopes of 45.52 pCi/L. Both of these wells were sampled in April 2003. The nitrate concentration in Well 46393 had dropped to 370 mg/L and total uranium activity had dropped to 27.68 pCi/L. Similar nitrate concentrations of 400 mg/L were found in Well 40193 although the total uranium isotopes were much higher at 185 pCi/L. The drop in concentration, especially in nitrates, is most likely because of its movement downgradient to areas like the discharge gallery. Nitrates are more mobile than VOCs and uranium. Although movement downgradient could have been facilitated by the ITS piping, the speed of its movement appears to be more consistent with groundwater movement alone because it has taken four to six years to appear.

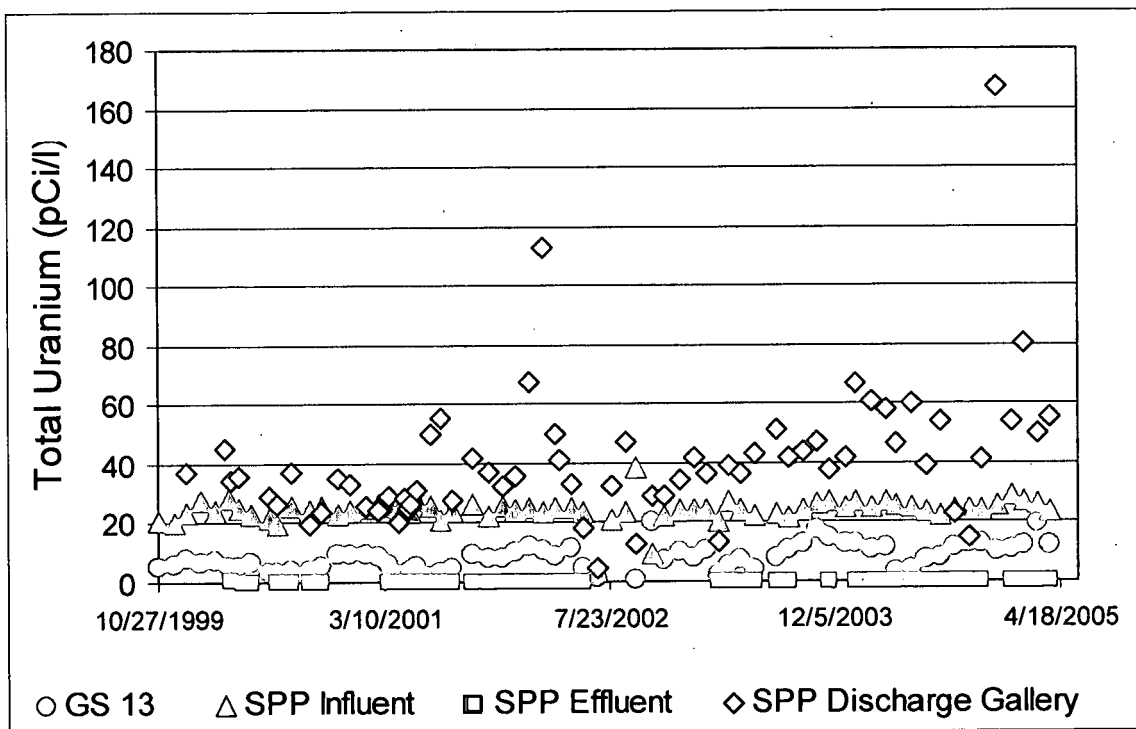
Figure 18. Uranium Activities in Solar Ponds Surface Water Locations

As indicated in Table 22, Table 23, and Figure 18, uranium activities at GS13 were greater than 10 pCi/L for six months out of twelve in 2003 and seven out of twelve months in 2004; however, the average activity was below 10 pCi/L during both years. In addition, in 2004, sample results from the outfall of Pond A-4 (that is, GS11, the RFCA point of compliance [POC] for uranium), remained below 10 pCi/L throughout 2003 and 2004. Total uranium activities ranged from 1.8 to 4.2 pCi/L in 2003. Slightly lower values were observed in 2004 with total uranium isotopes ranging from 1.3 to 3.3 pCi/L.

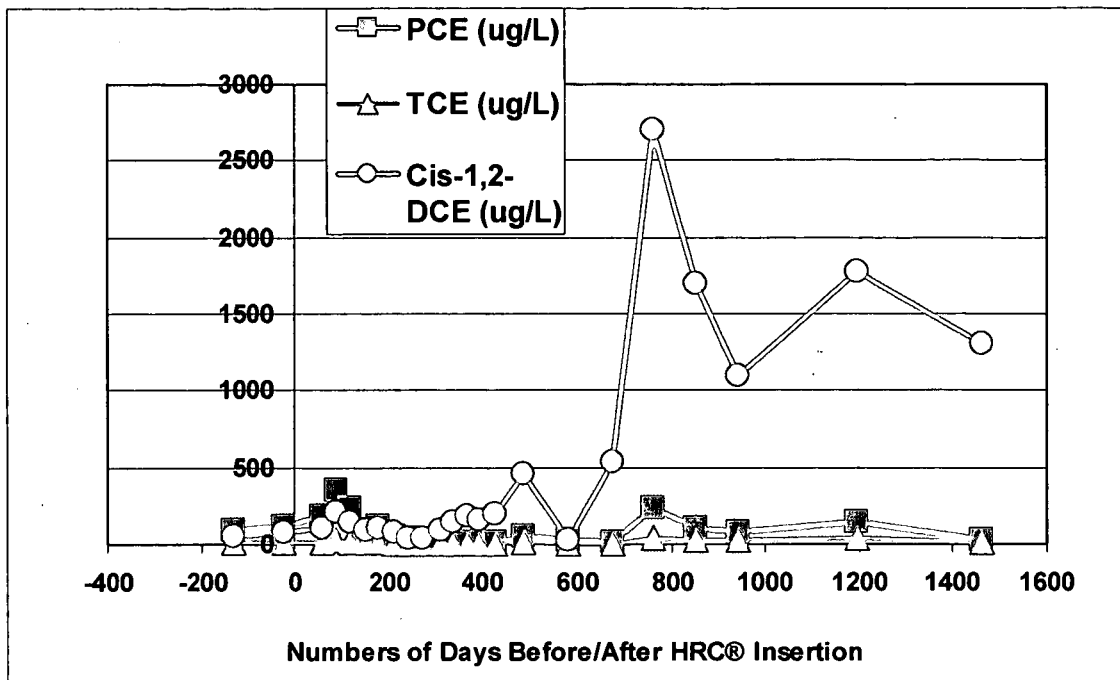
Figure 24. PCE and Degradation Products Concentration versus Time in Well 30900

Although the concentration of PCE increased, it did not exceed past high concentrations in the source area. Both TCE and cis-1,2-dichloroethene concentrations did exceed past values. This could be an indication of a more robust microbial population since it appears that more contaminants were liberated from the soil and a greater quantity was degraded. Based on previous years experience, it is anticipated that the cycle will repeat again in 2005, although the effect might not be as pronounced. As indicated on Figure 25, data from the downgradient well (Well 31001) show a similar pattern.

Figures 24 and 27 also show cis-1,2-dichloroethene occurs at higher concentrations in the source area than downgradient. The accumulation of cis-1,2-dichloroethene at enhanced biodegradation sites is known both here and at other sites. Although there could be others, only one type of bacteria, *Dehalococcoides ethenogenes*, is currently known to anaerobically degrade cis-1,2-dichloroethene (Maymó-Gatell, et al. 1999). Recent research (Kean, 2003) has found that when the concentration of hydrogen donors is high, cis-1,2-dichloroethene degradation is arrested and will accumulate. As previously mentioned, the increase in hydrogen donors is associated with the rise in water table flushing HRC®, ketones, and other hydrogen donors out of the vadose zone. When the concentration of hydrogen donors drops, such as downgradient from the insertion area, *Dehalococcoides ethenogenes* is better able to compete with other bacteria (methanogens) for available resources and cis-1,2-dichloroethene concentrations drop.

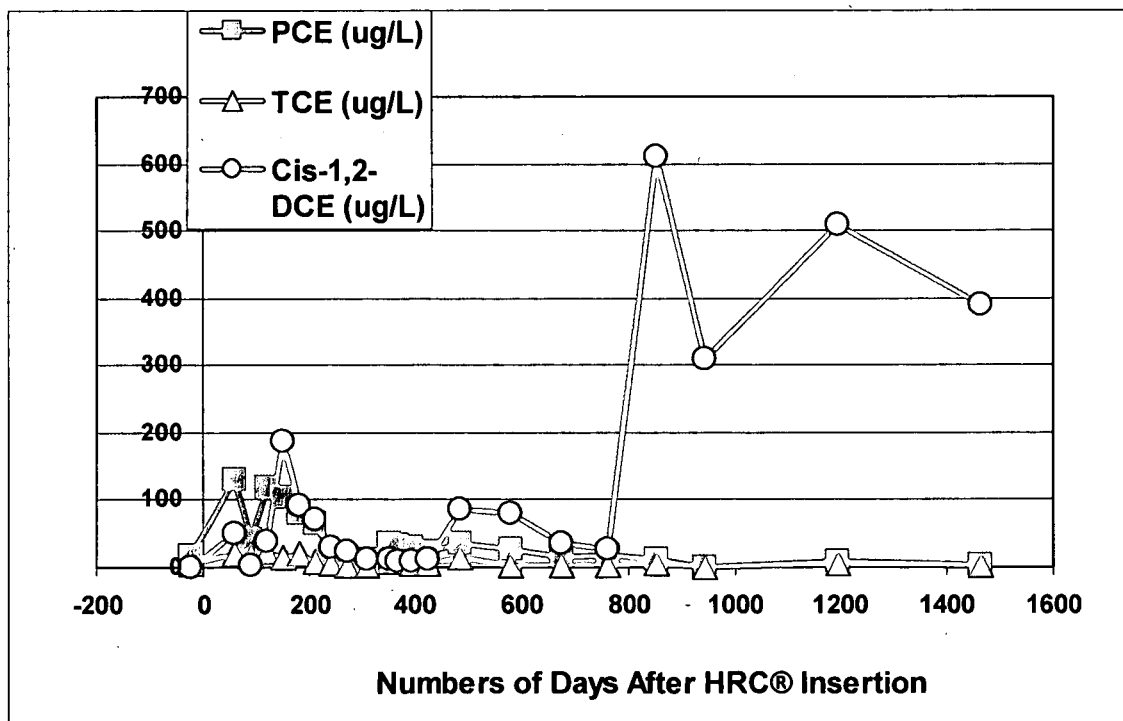
Figure 25. PCE and Degradation Products Concentration versus Time in Well 31001

When the water table rises, the area of reduced conditions and anaerobic activity get larger and more hydrogen donors are present; the concentration of cis-1,2-dichloroethene increases as shown on Figures 25 and 26. Farther out from the anaerobic core where the concentration of

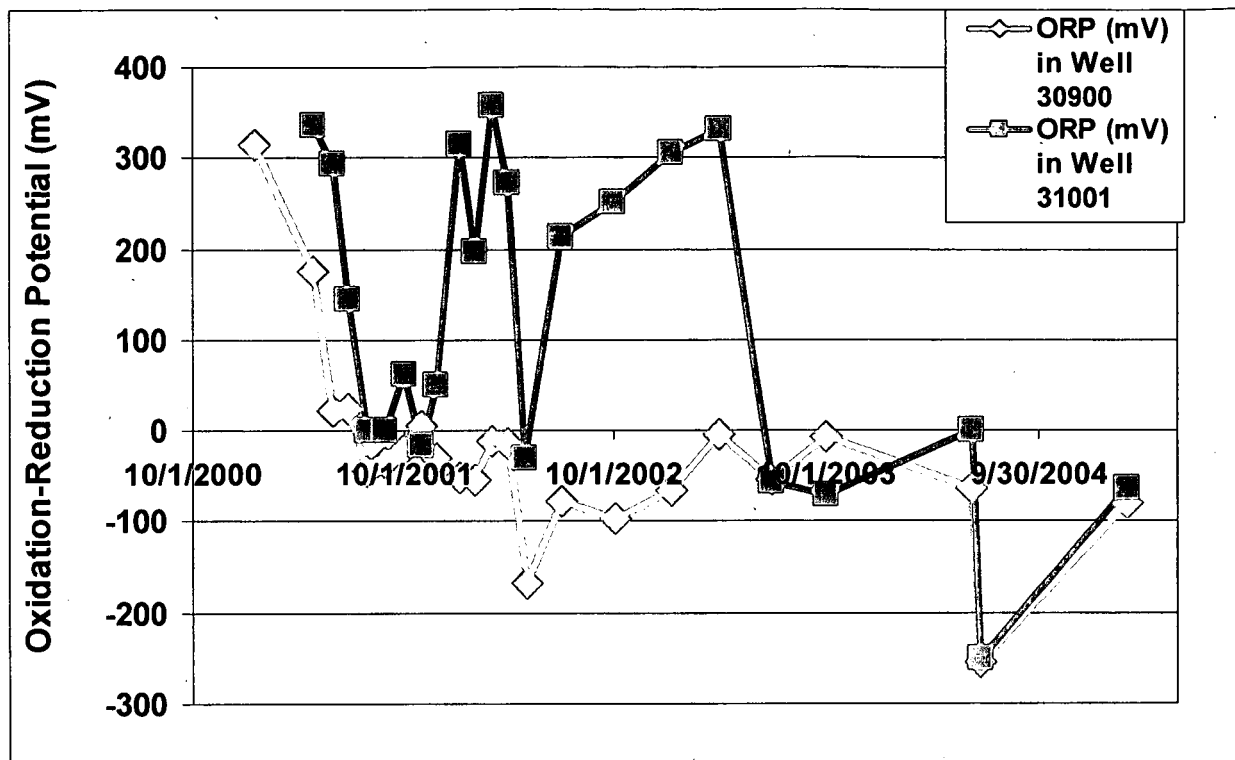
Figure 29. ORP in PU&D Yard Wells versus Time

hydrogen donors is lower, cis-1,2 dichloroethene degradation is probably occurring as it does when the core shrinks in the fall and the ORP rises in Well 31001.
